24th and 25th
September 2013

WORKSHOP ON STRUCTURAL
REHABILITATION AND RETROFITTING
USING
CONSTRUCTION CHEMICALS

Proceedings of the Workshop on Structural Rehabilitation and Retrofitting using Construction Chemicals – 2013 (WSRR 13)

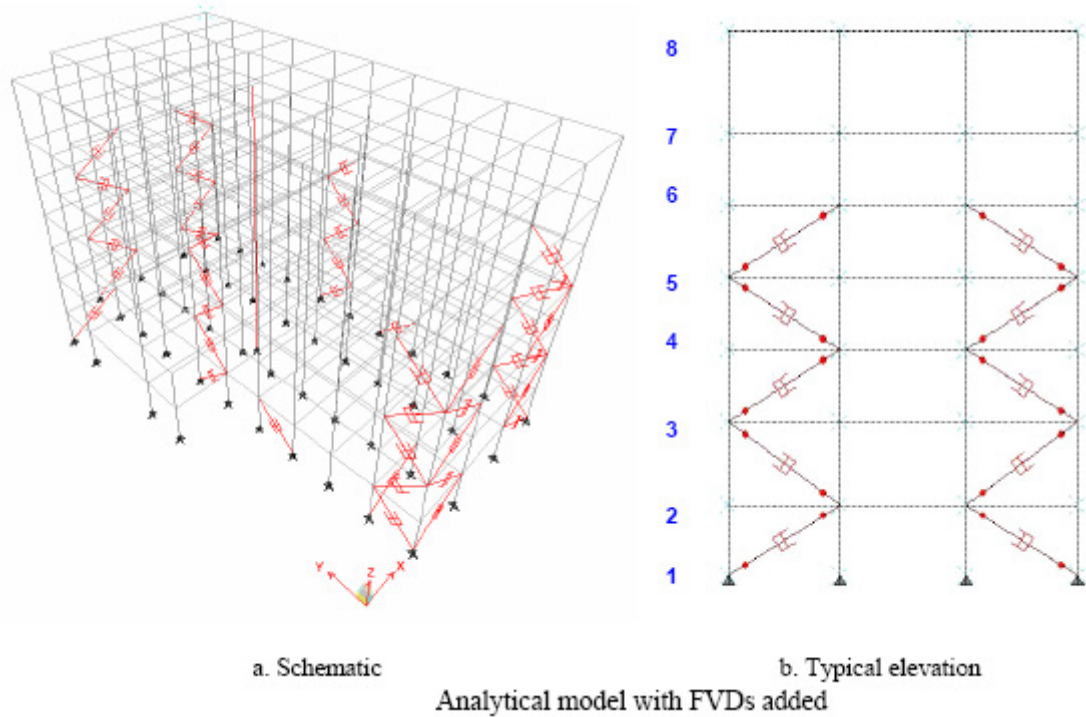
Figure - 6

The analytical model for this analysis was similar to the last model with one exception, all members were assigned mass-less properties and the floor lateral and rotational masses as given in Table 1 were lumped at a point having 5% eccentricity with respect to center of mass. Since the center of mass at each floor is offset in the -x and +y directions from the center of rigidity, the additional 5% offset was placed in the same quadrant to maximize the torsional demand. Additionally, dampers were added to the model as shown in figure 6.

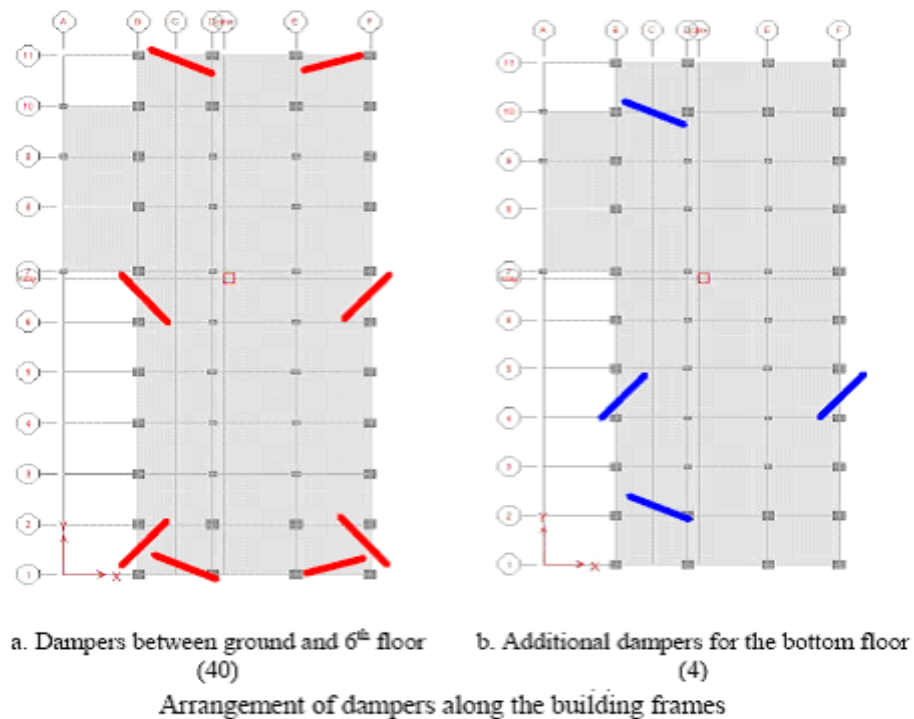
Figure - 7

Eight dampers (four in each direction) as shown in Figure 7, were used in second to fifth floors. Since the drifts were largest in first floor, 12 dampers were used at this level. The damping properties were selected to provide approximately 20% of critical supplementary damping at each level. Larger damping ratio was used at the first level to reduce the story drifts further.

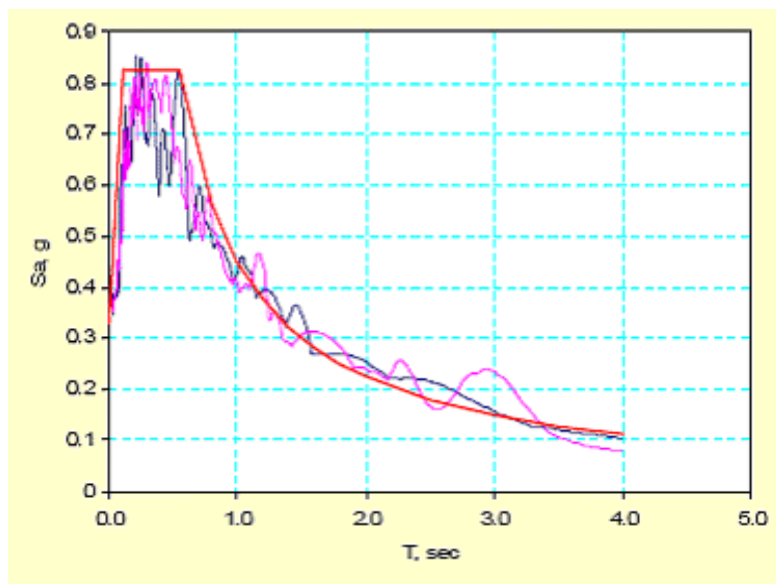
Figure - 8

A pair of acceleration histories whose response spectra closely matched that of Figure 5 was used to perform nonlinear response history analyses. The resulting acceleration record and spectrum are shown in Figure-8. In analysis, the two components of the record were applied in x- and y-directions concurrently for two separate analyses.

a. Spectrum-compatible motion

b. Target and analyses spectra
Acceleration record used in analysis

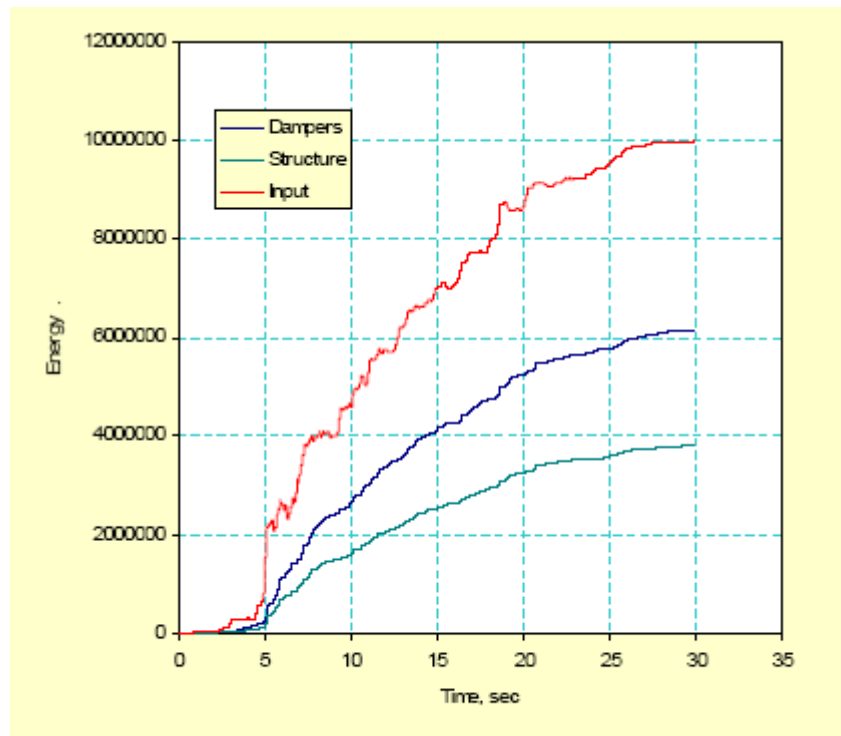
Figure 12 presents the normalized components of the seismic energy. Note that the dampers, indicated by the solid blue line, dissipate the most significant part of the input seismic energy. This is critical because if dampers do not dissipate this then this energy would be absorbed by the structure and cause yielding of concrete members resulting in structural damage to beams and columns.

Components of seismic energy

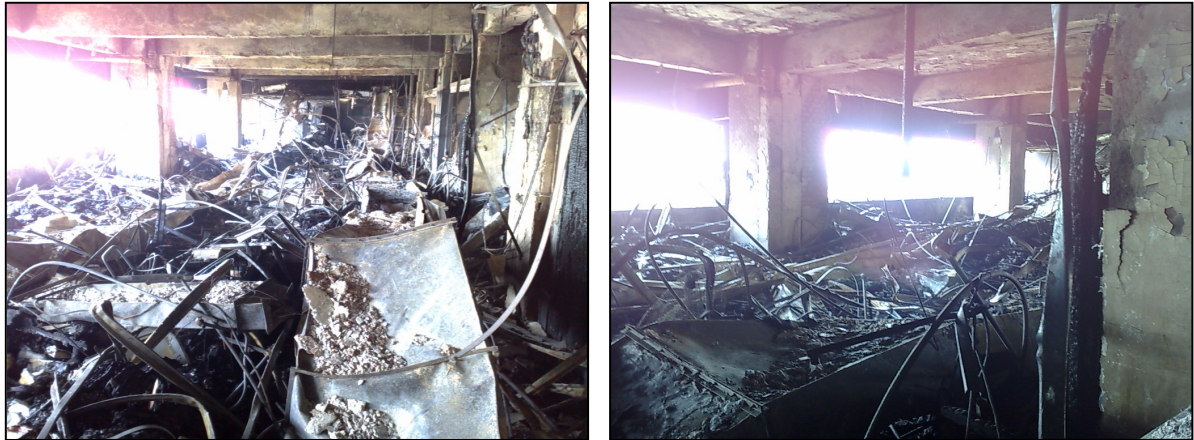
Figure 2. Severe fire damages at 4th floor of the building

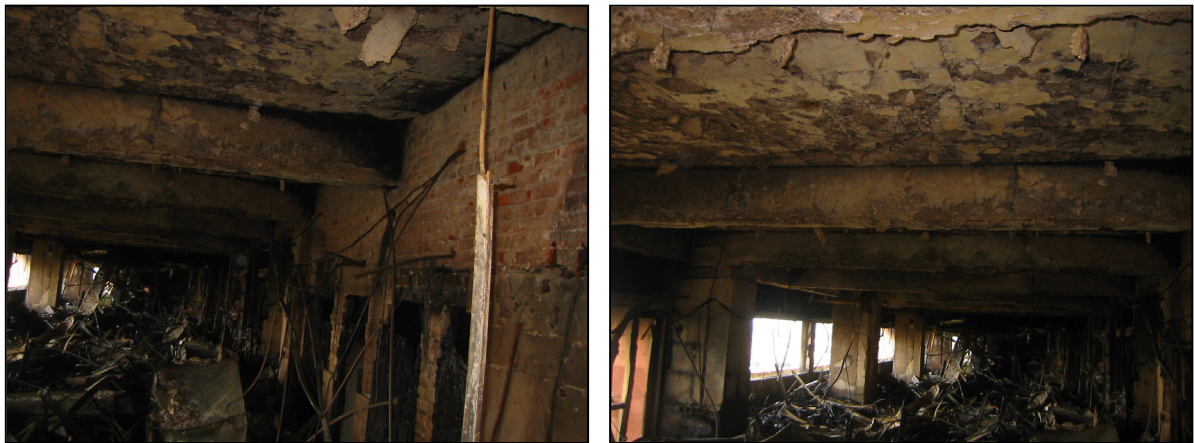
Figure 3. Another view of fire damages at 4th floor of the building

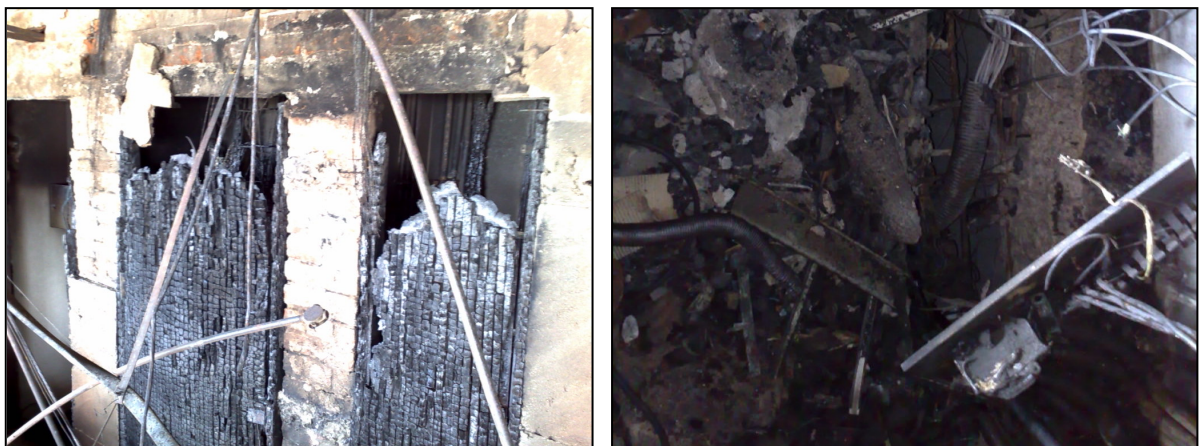
Figure 4. Severe damages to service shafts at 4th floor

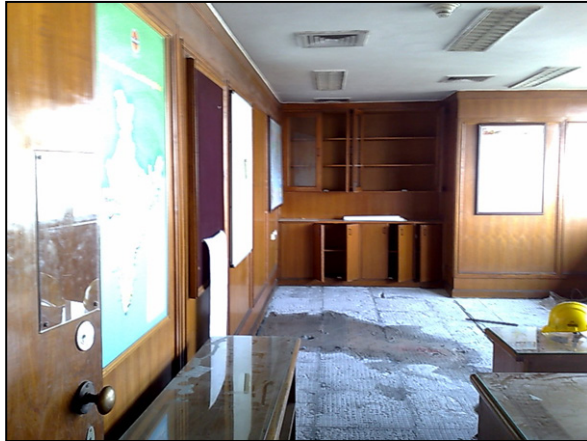
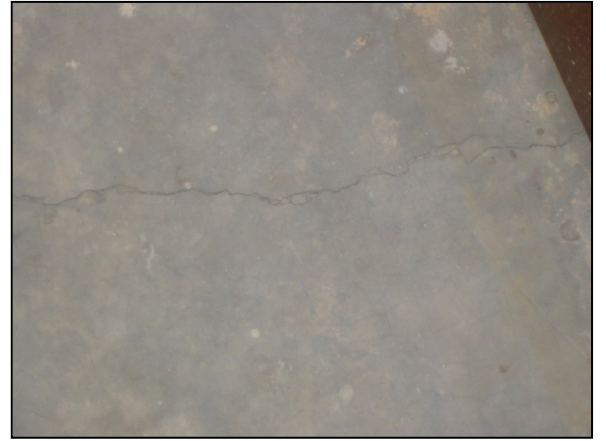
Figure 5. Delamination of tiles and cracks at 5th floor of building

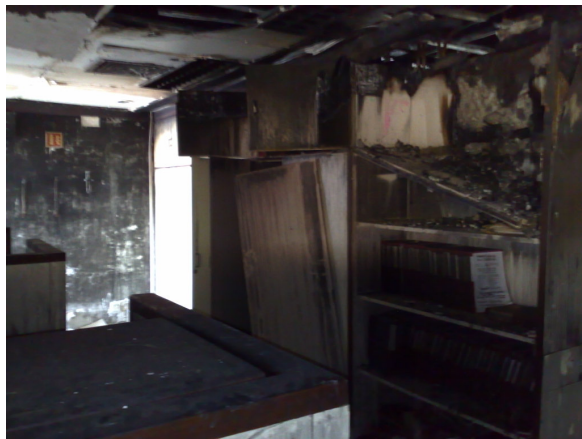
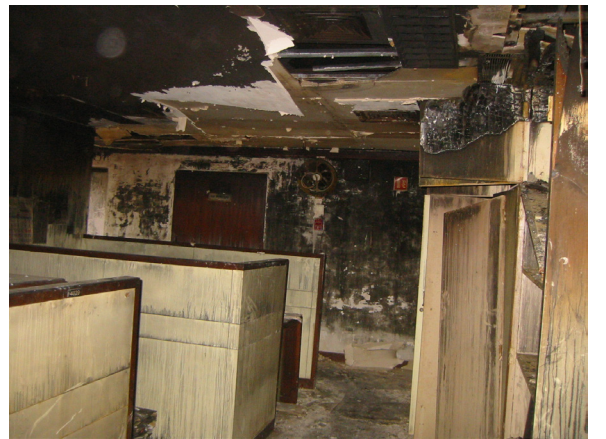
Figure 6. Damages in other part of building due to smoke & hot gases

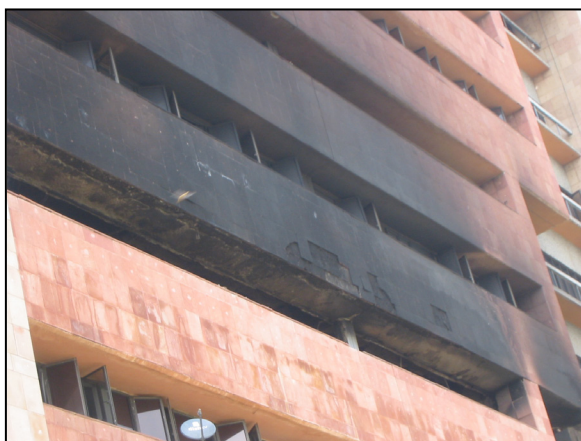
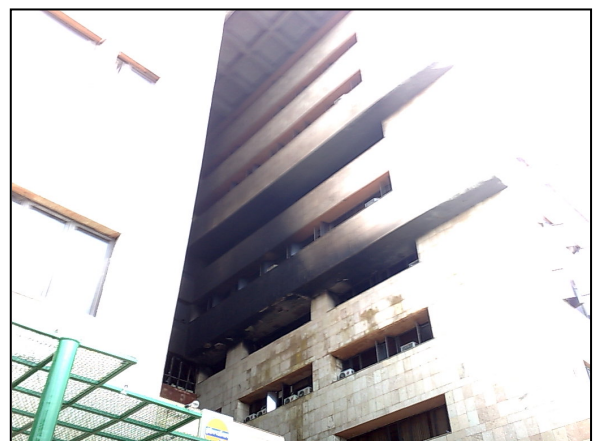
- A few stone cladding on external facia is found delaminated and spalled from the surface due to fire exposure even though they are properly anchored with the surface. Further, it was observed that a few stone cladding has debonded with the surface causing falling hazard.

Figure 7. Delimitation of stone cladding and soot deposition on fascia of building

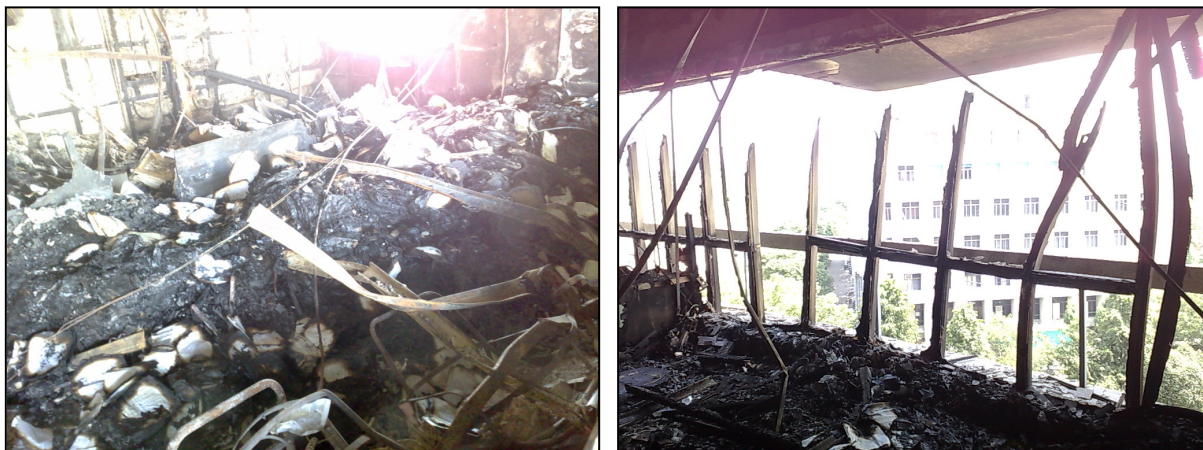
Figure 8. Presence of Highly Combustible Materials at 4th Floor

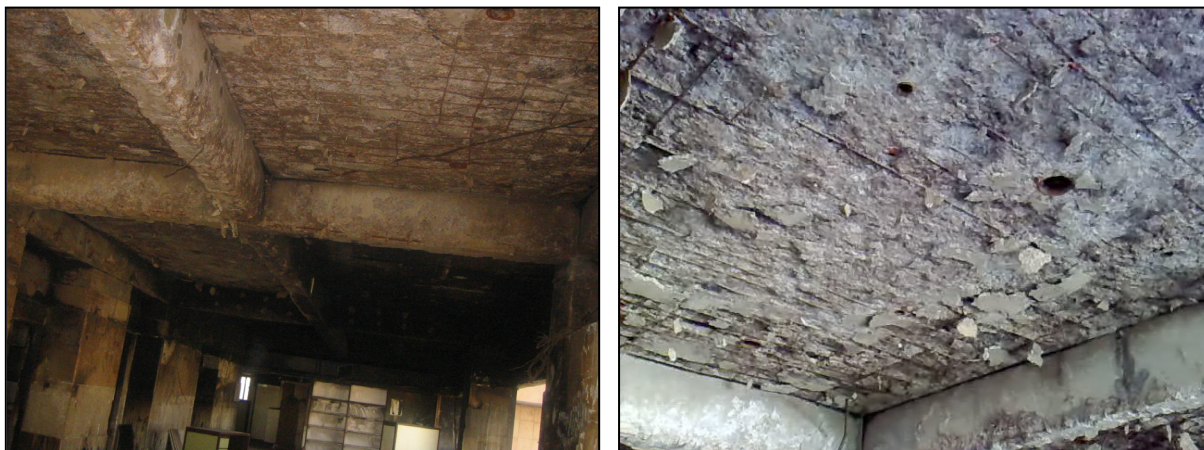
Figure 9. Spalling of Cover Concrete in Roof Slab of 4th Floor

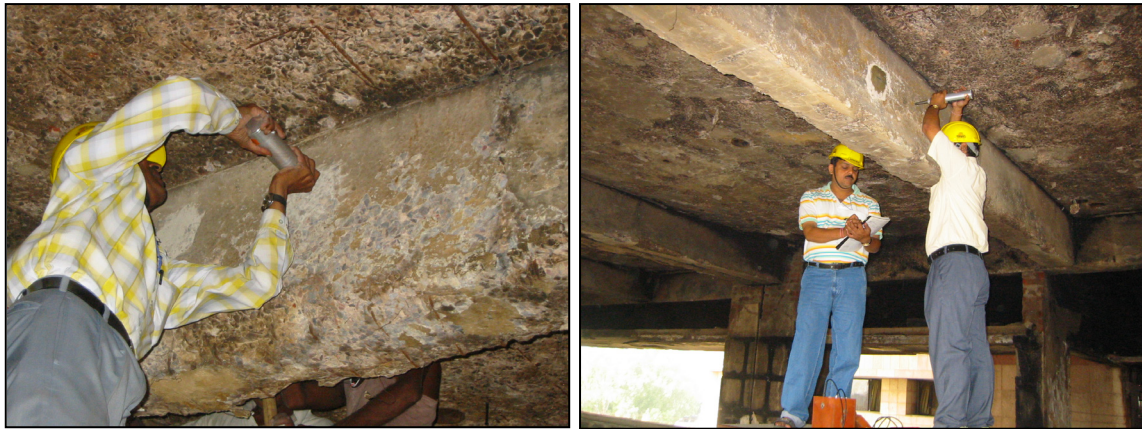
Figure 11. Rebound hammer testing of beams on fire damaged portion

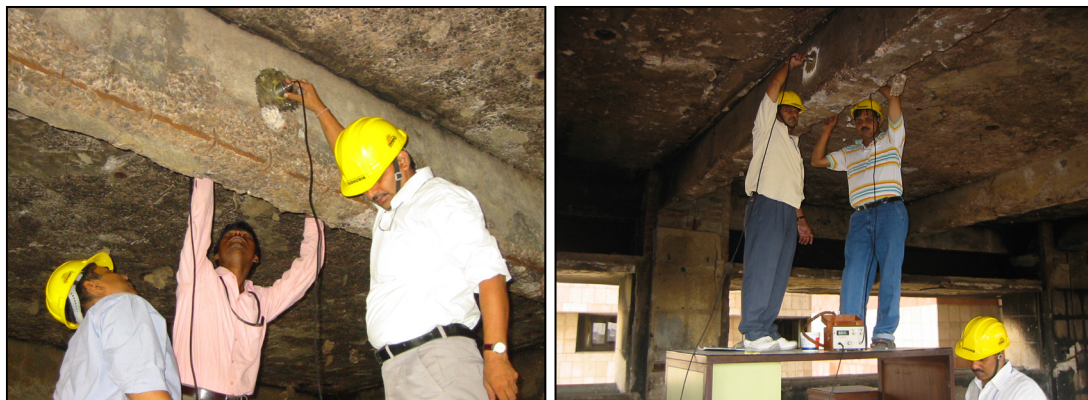
Figure 12. Ultra-sonic pulse velocity testing of fire damaged beam

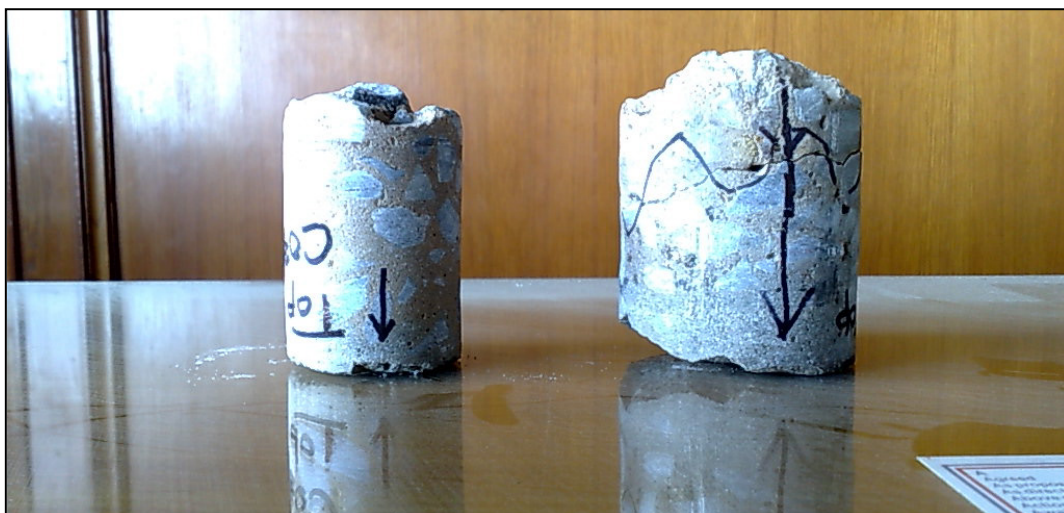
Figure 13. View of honeycombed cores with fractured plane

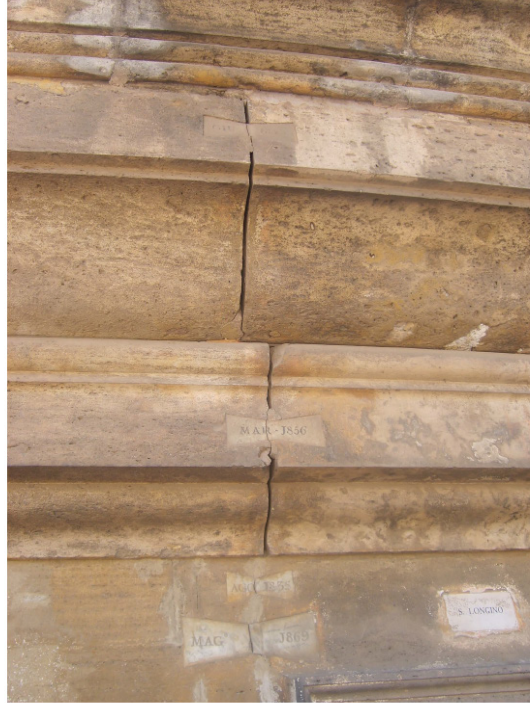
Figure 2: Evidences of meridional cracks in St. Peter cathedral

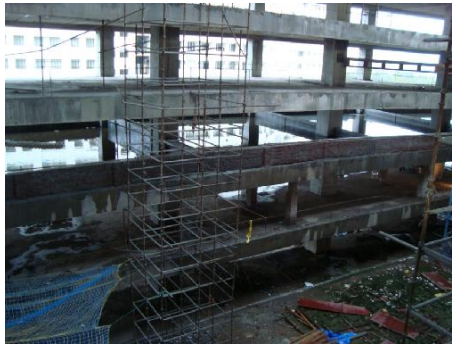
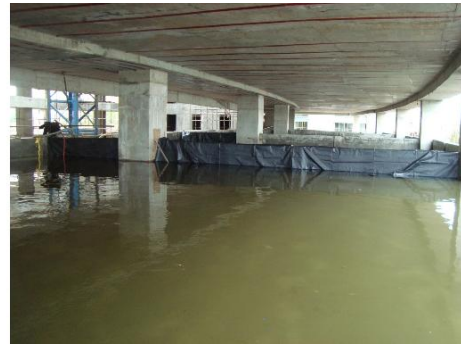
Fig. 15, 16: Water ponding for uniform load

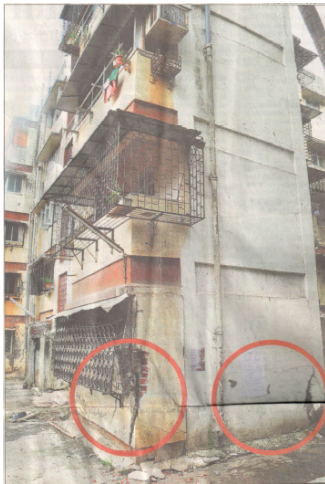
Fig.1 Failure of columns in RCC structure
